St Mary's Episcopal Church, Kirriemuir

Fabric Condition Report

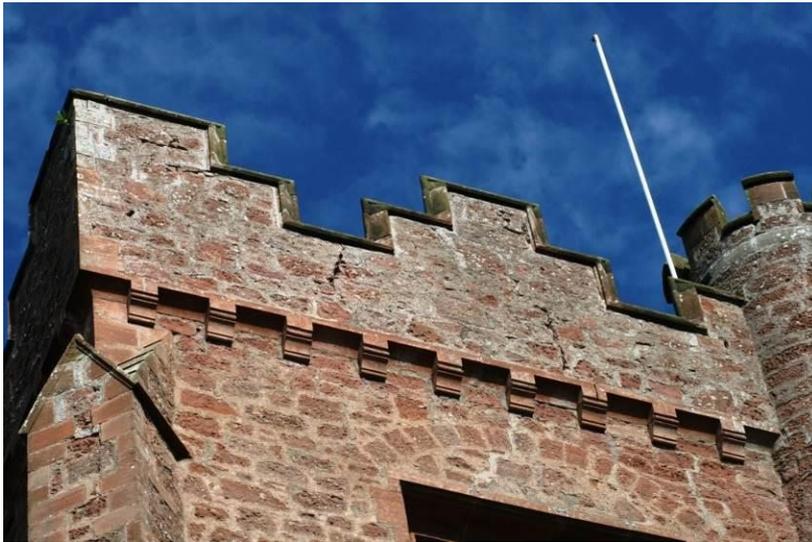
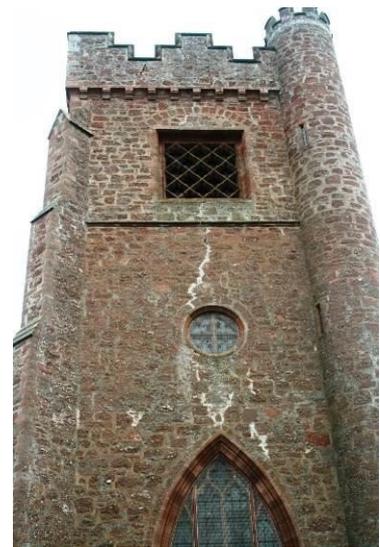
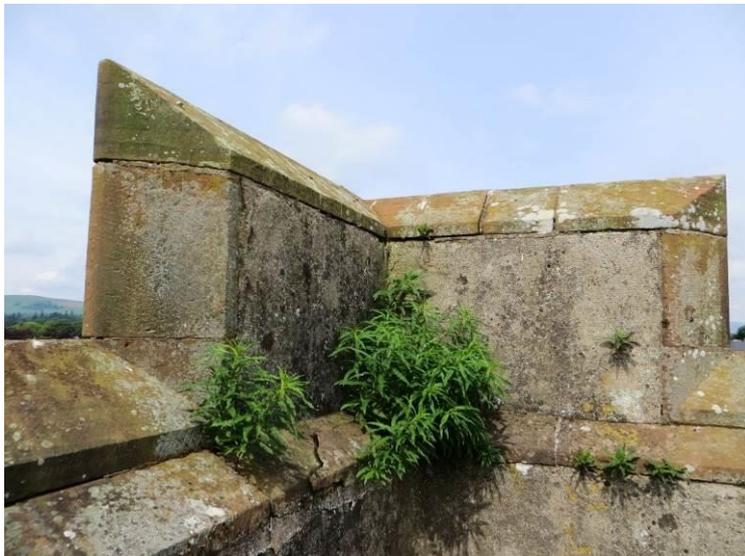
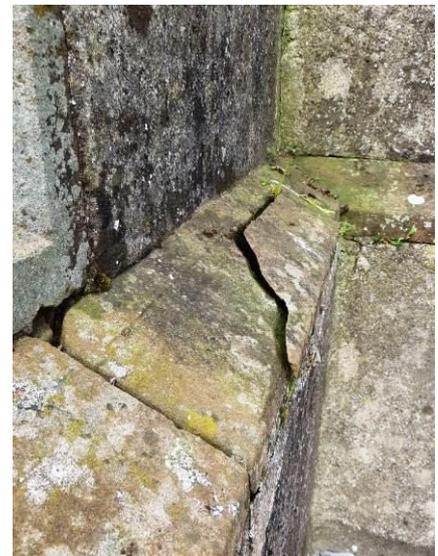
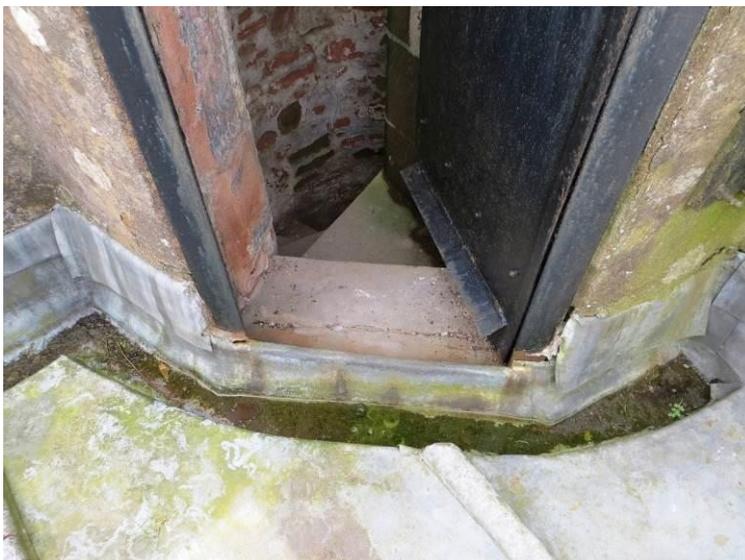
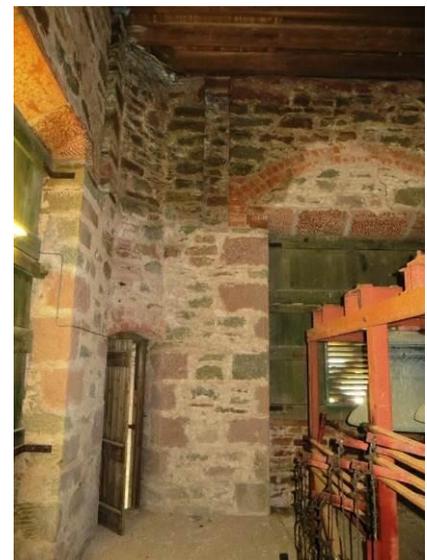
There has been historic movement in the tower particularly on the west and north elevations. Mortar repair of previous cracks is evident and a number of these have reopened (fig 5). There has been replacement of stone lintels in the belfry and other masonry repair in the store room below. The corner stair tower has also experienced movement with cracking through stone steps, the central spine and around the entrance door from the Baptistery (fig 15).

The lead flat roof over the main tower is ageing with splits in the lead especially around the entrance door from the stair (fig 5) and at the welded roll joints.

The masonry which forms the crenulated parapet is in poor condition. The internal face has a render finish which is failing and has been previously patched in a number of places. The render is cracked allowing water ingress to the masonry core. The sandstone copes have open joints and at the NW corner vegetation is forcing joints open more significantly and there is a damaged cope with a loose stone piece on the internal face (fig 5). There are a number of large open joints / reopened cracks on the external masonry face (fig 5).

In the belfry, the internal masonry is damp at high level in all corners. This would indicate water leakage from the lead roof junctions and possibly through the masonry itself. This water ingress is most prevalent at the NW and SW corners, the SW corner being below the flashing at the stair door (fig 5). The timber structure of the roof, which could only be viewed from below, shows signs of prolonged water ingress suggesting that rot could potentially be present.

Figure 5: (From top) parapet masonry in poor condition; previous cracking on W elev; plant growth in open joints; cracked cope; water ponding at stair door; water ingress in belfry below stair door.

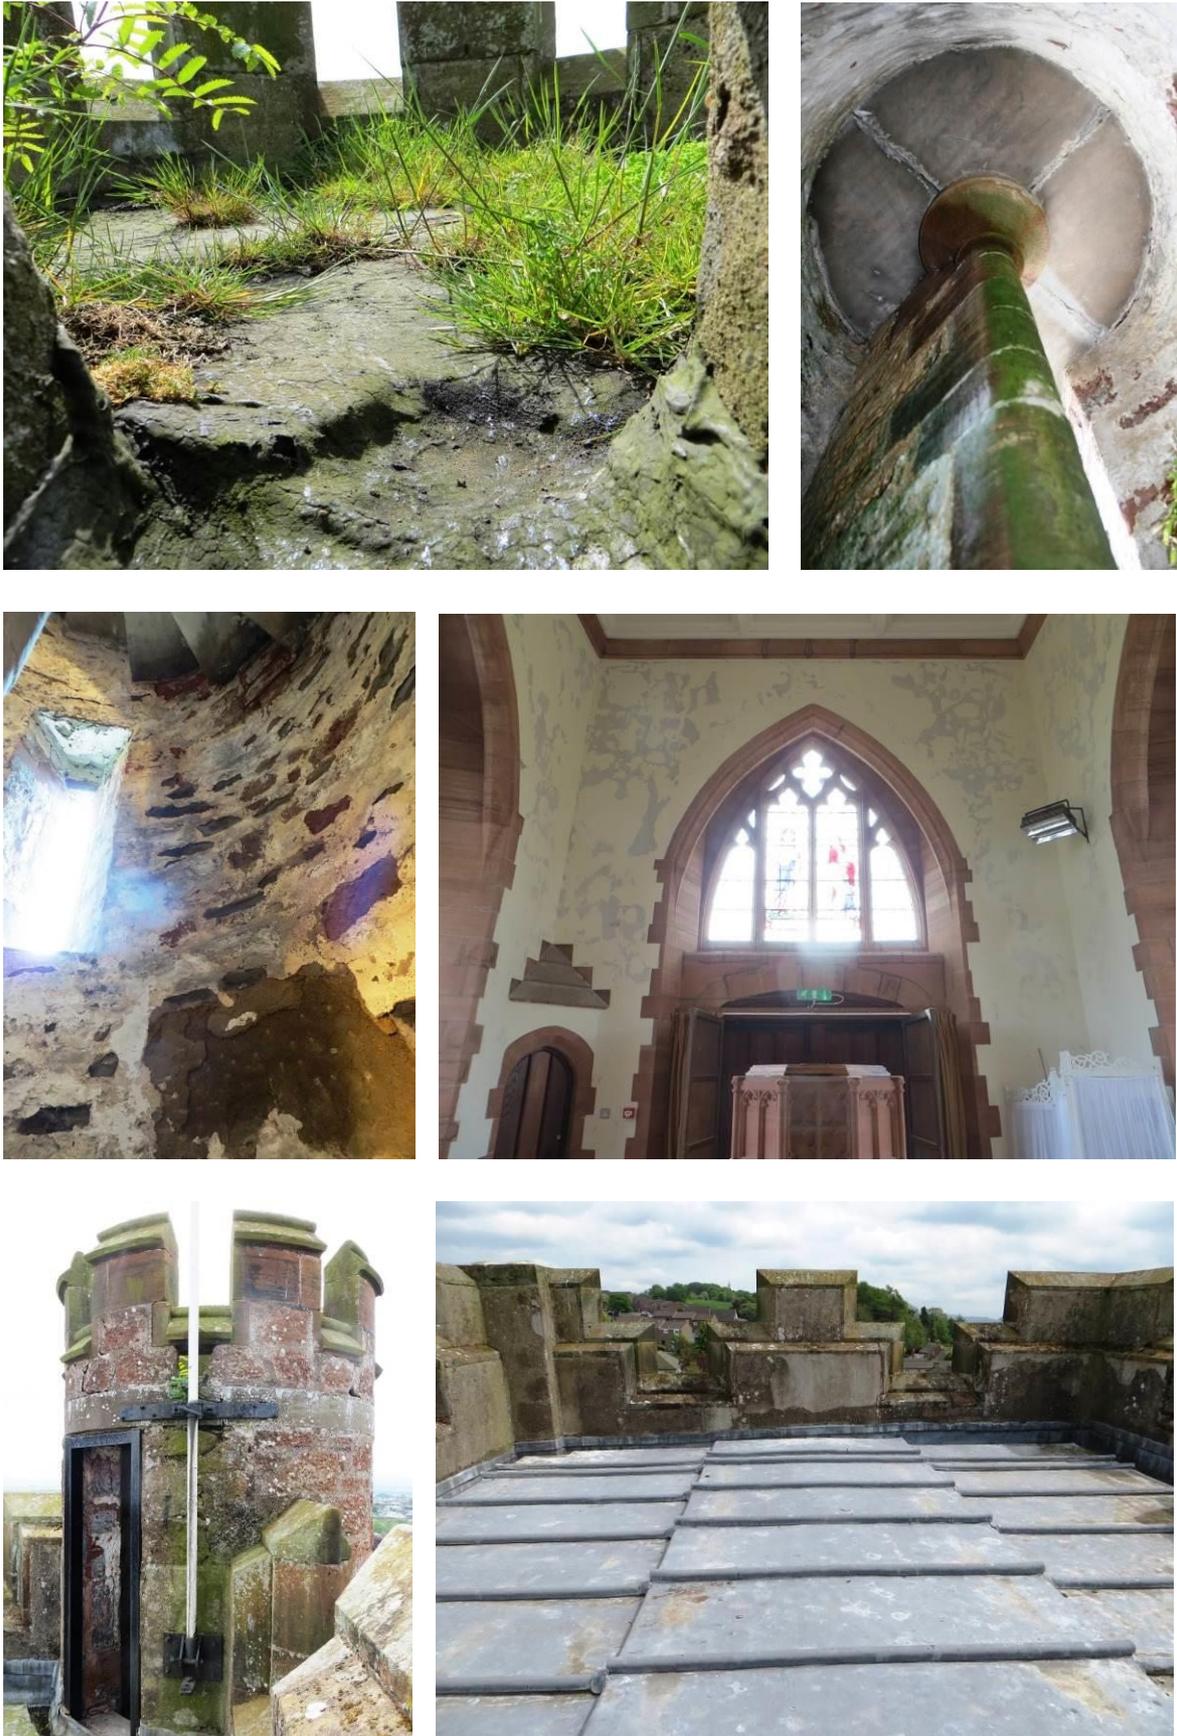
The stair tower has a solid roof construction with possible bitumen / asphalt coating which has failed causing water damage at the head of the stair (fig 6). In general the internal face of the stair is in poor condition with spalling masonry and failing paint finishes, damp ingress and mould growth in places, and cracking / failure of mortar pointing in numerous places (fig 6).

The Baptistery at the ground level has suffered from flaking paintwork (recently cleaned off; fig 6). It is possible this is a result of penetrating dampness through the core of the wall (this type of rubble construction will contain voids which makes the water ingress easier). Below ground the crypt appears to suffer from a rising water table and a pump has been installed which was found to be disconnected. Water was sitting over part of the floor during the second site visit. Further investigation is required to confirm the cause of the flaking paintwork and the water levels effecting the basement.

Figure 6: The roof of the stair tower where the roof finish has failed allowing water to penetrate the central spine shown with algae growth; the internal masonry of the tower is spalling in numerous places; the Baptistry has suffered from flaking paint surfaces; the stair tower; the lead roof.

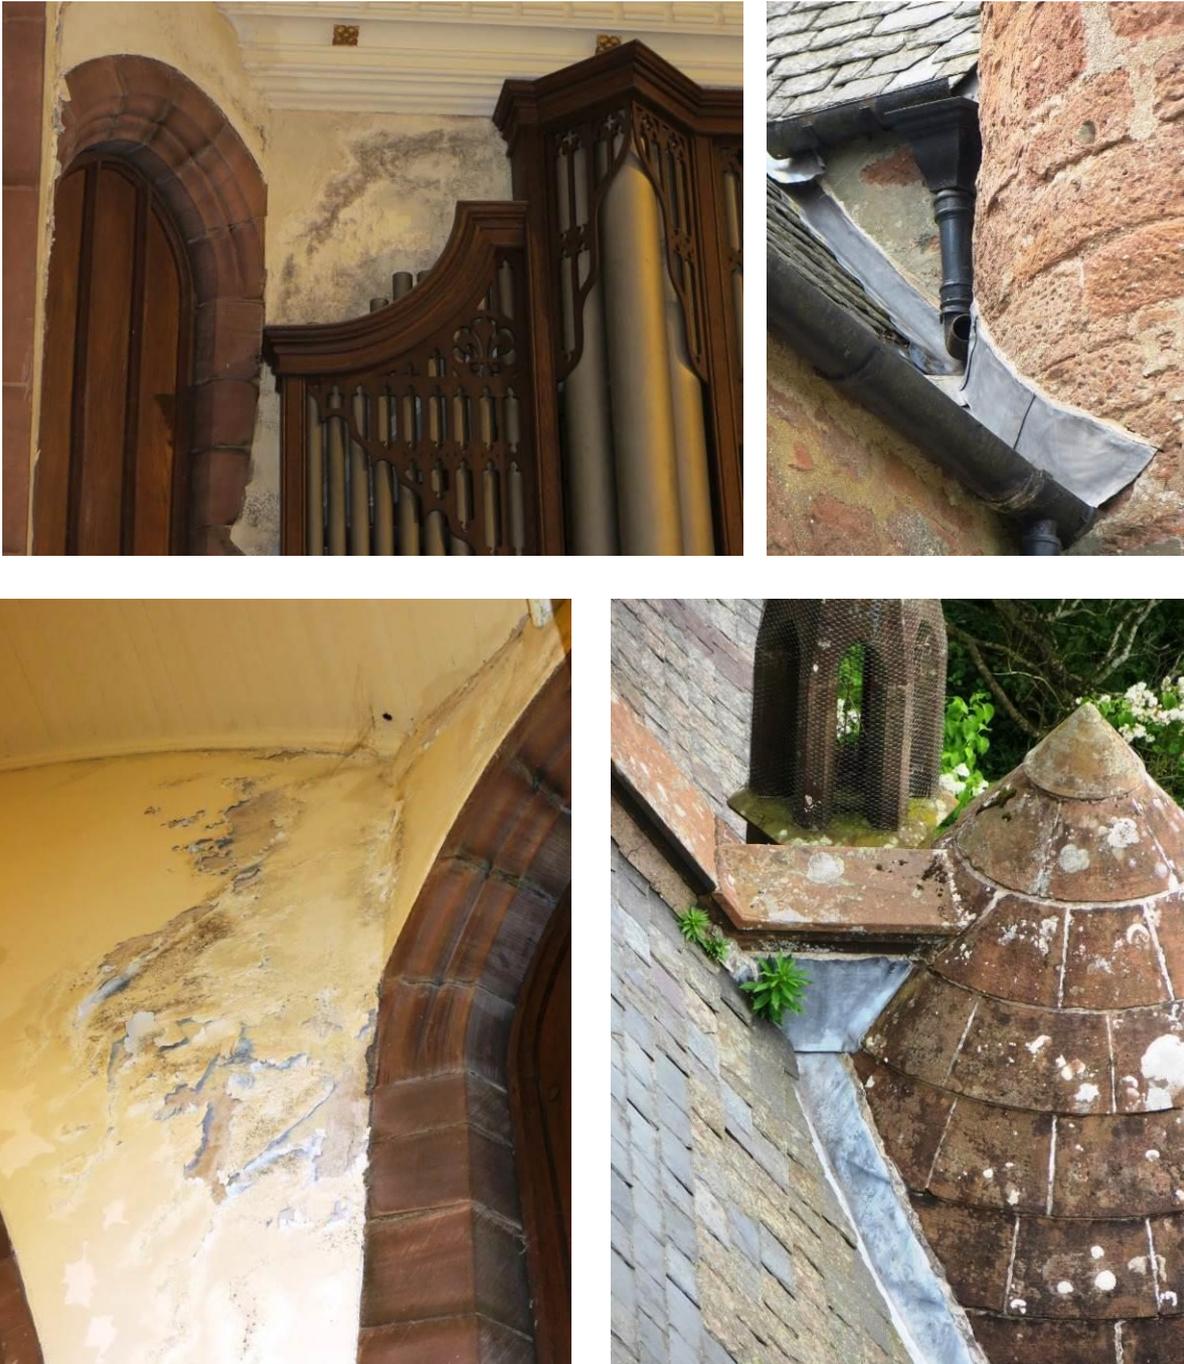
1. The east gable at high level on both sides of the Nave and extending onto the south wall behind the organ (fig 7);
Probable cause – Gable wall: failure of the mortar skew fillet below the copes; failure of lead flashing at SE Stair Tower junction; possibly failure of cope joints. South wall: failure or overspill from the rainwater goods at the complex junction of the SE Stair Tower / Porch and Nave (fig 7).

Figure 7: Effects of water penetration on the south wall behind the organ and externally the complex junction of Nave / Tower /Porch; (below) effects of water penetration at the south corner of the east gable possibly a failure of the lead flashing and / or mortar skew fillet below the cope.

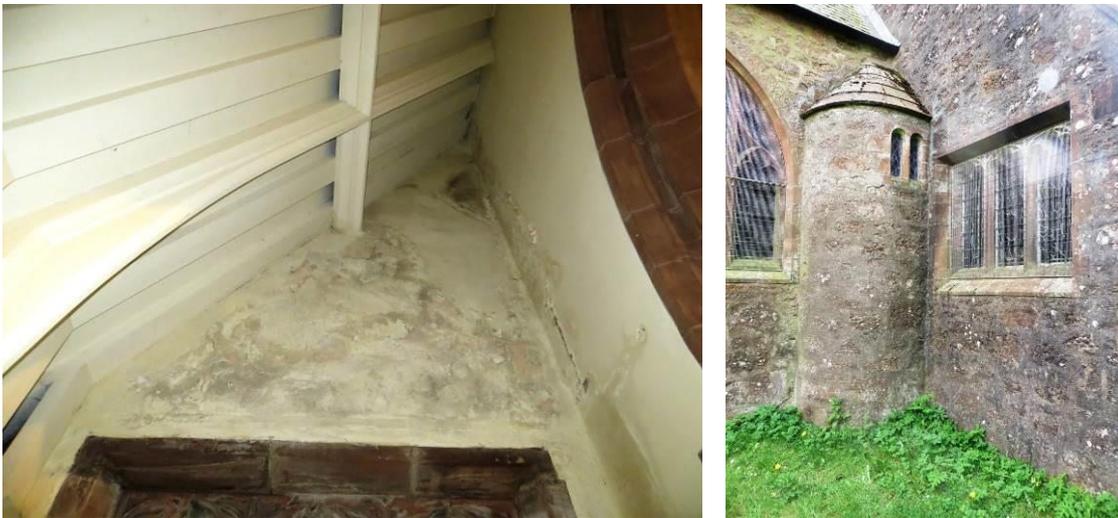
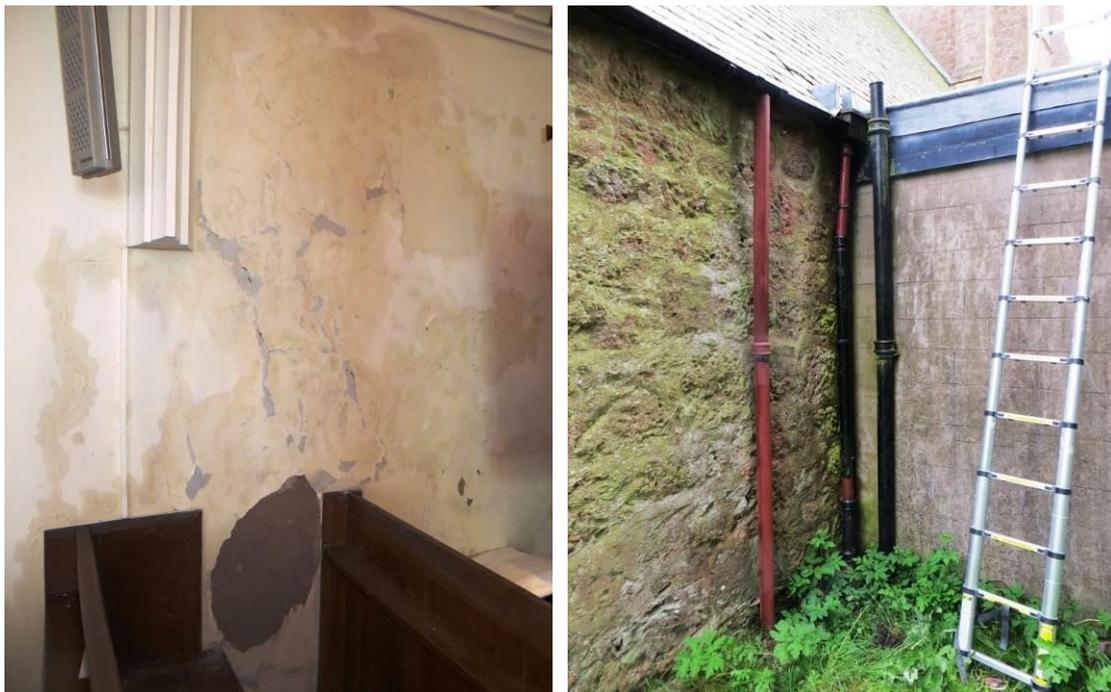
2. The east wall of the north aisle above and around the tripartite window; salts leeching through the dressed stonework (fig 8).

Probable cause: As pt 1. above, possible failure of the mortar skew fillet below the cope and cope joints. Externally the aisle wall which has been heavily overpointed with previous cement pointing repairs at the junction with NE tower. No flashing to the NEW turret and poor condition of wall pointing could be adding to saturation of the masonry.

3. The north wall of the aisle (area recently cleaned of black mould; fig 8).

Probable cause: defective rainwater down pipe and / or overflowing hopper (fig 8). Rainwater hopper choked with pine needles from adjacent trees (roughly cleared during inspection); alignment of downpipe from the hopper is not true and discharges with an open end over an outlet grille.

Figure 8: Effects of water penetration above and around the window in the north aisle. (below) damaged plasterwork in the north aisle coincides with downpipes and hopper at hall junction.

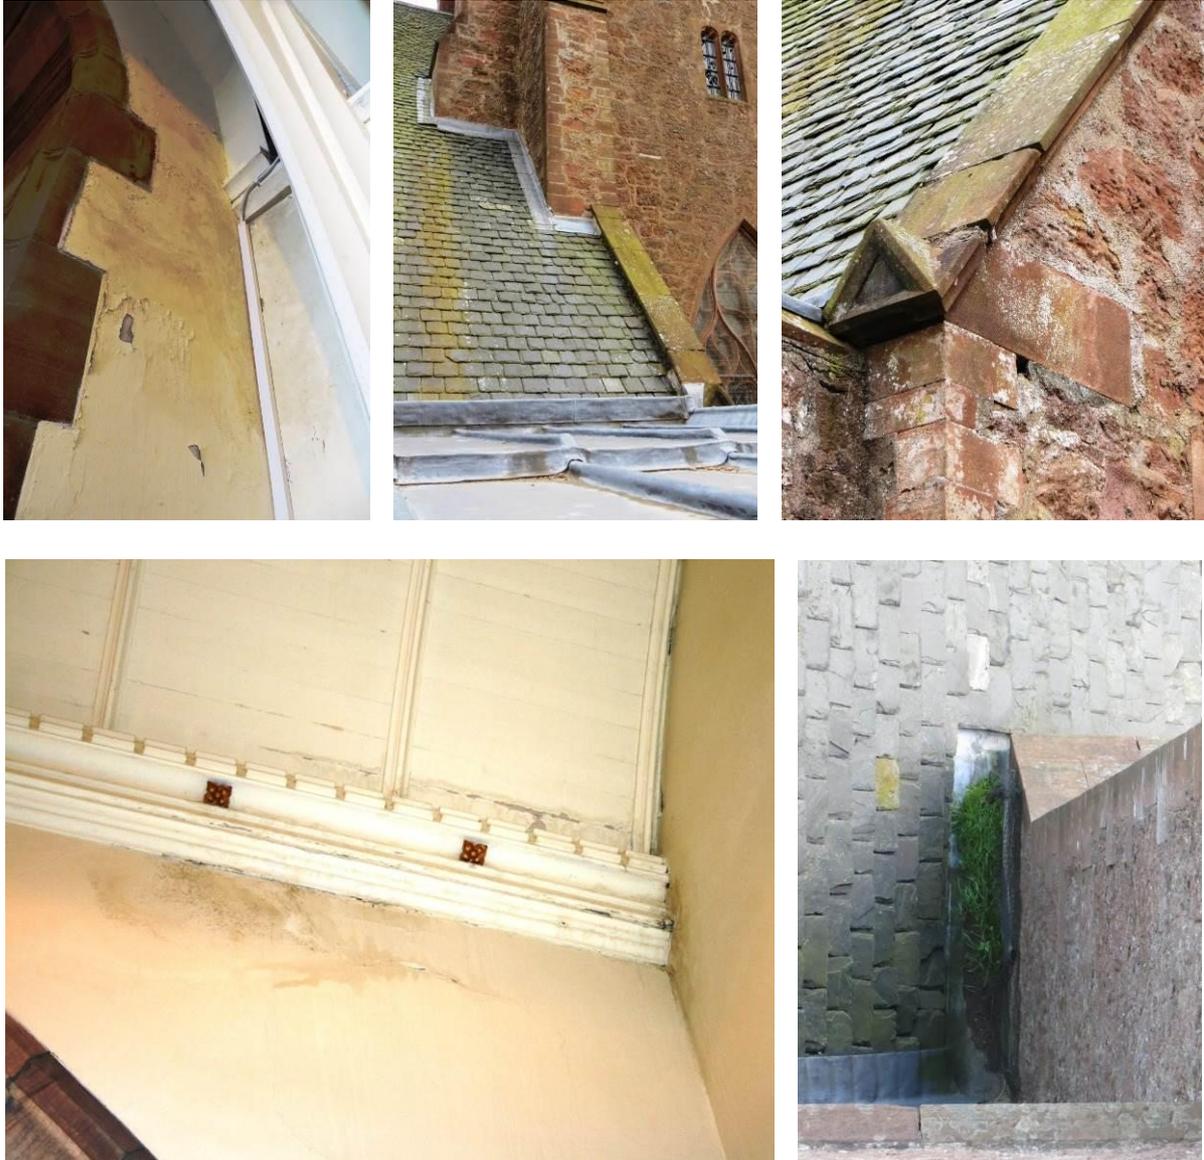
4. The west wall of the north aisle above the bipartite window (fig 9).
Probable cause: failure of the mortar skew fillet below the copes; failure of cope joints; masonry below copes in poor repair (fig 9).

5. The south-west corner of the Nave at high level/eaves (fig 9).
Probable cause: choked lead gutter behind buttress (fig 9).

Figure 9: Effects of water penetration on the west wall of the aisle; the roof junction is only protected by a mortar skew fillet and the masonry to the copes and gable wall head is in need of repair. (below) effects of water penetration at eaves level on the south elev; blocked lead gutter behind the buttress.

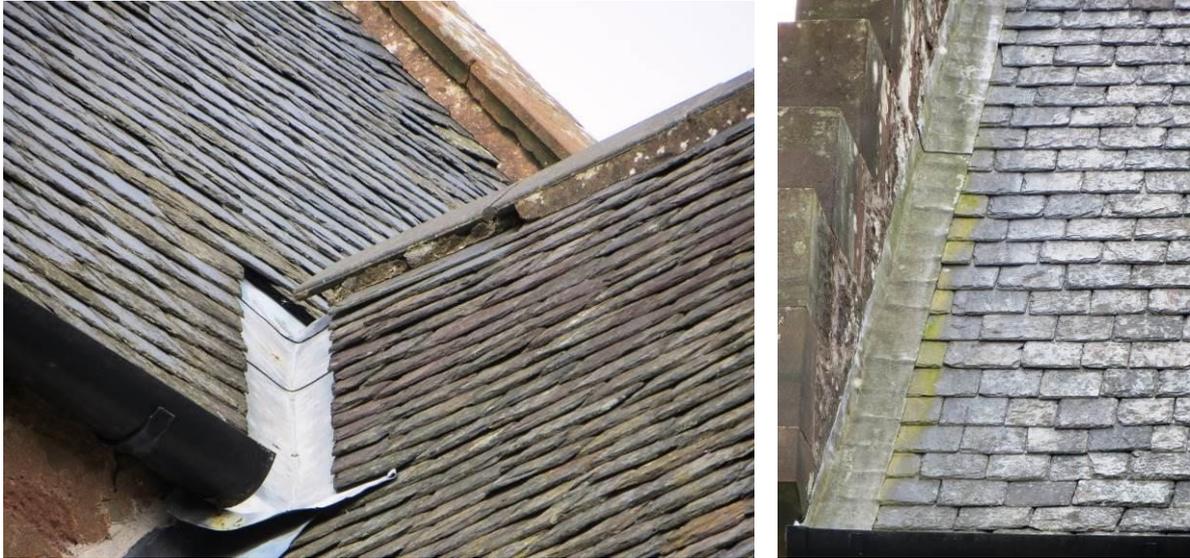
The bedding mortar of the clay ridge tiles is missing at the junction with the Nave roof. The gable crowsteps and high level masonry are in need of pointing. The lead over flashing at the abutment with the gable wall is of some age and has only a shallow return to the wall face, which could lead to water ingress (fig 10).

Figure 10: Damaged bedding mortar below clay ridge tiles; ageing over flashing at the roof abutment with the gable.

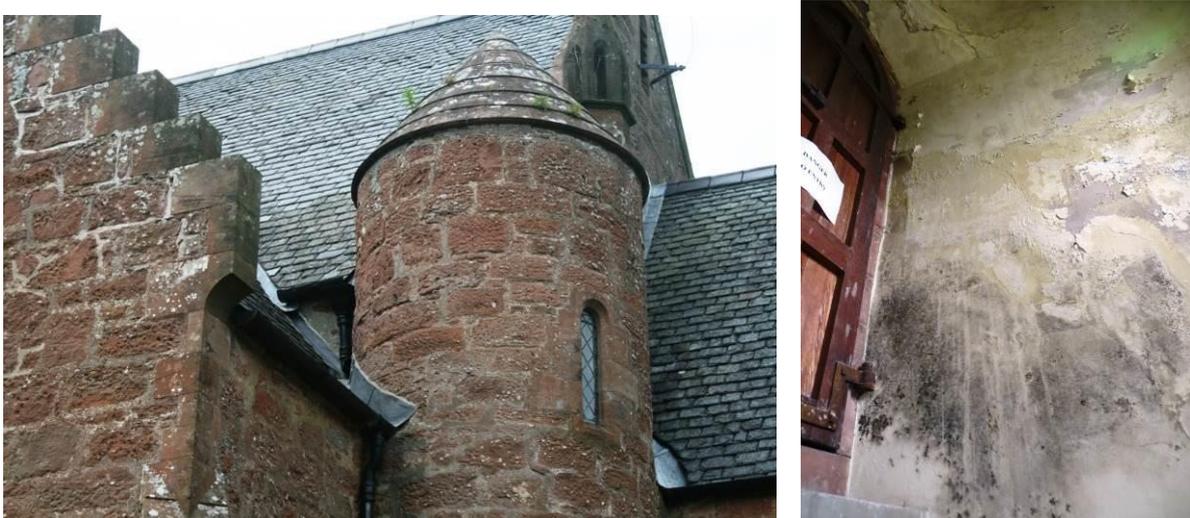
Water penetration is causing damage internally to plaster and paintwork especially at high level and around the upper doorway to the Nave (fig 11).

Probable cause: water leaching through stone flag roof and joints; no gutter. As with pt. 1 above, rainwater disposal at the complex junction of Porch/ Nave / Tower could be an additional cause if not kept clear or if insufficient during heavy rain / snow. No ventilation.

Figure 11: The stone capped SE tower abuts the Nave / Porch and Chancel; water penetration has damaged the internal plaster finishes particularly around the upper door to the Nave.

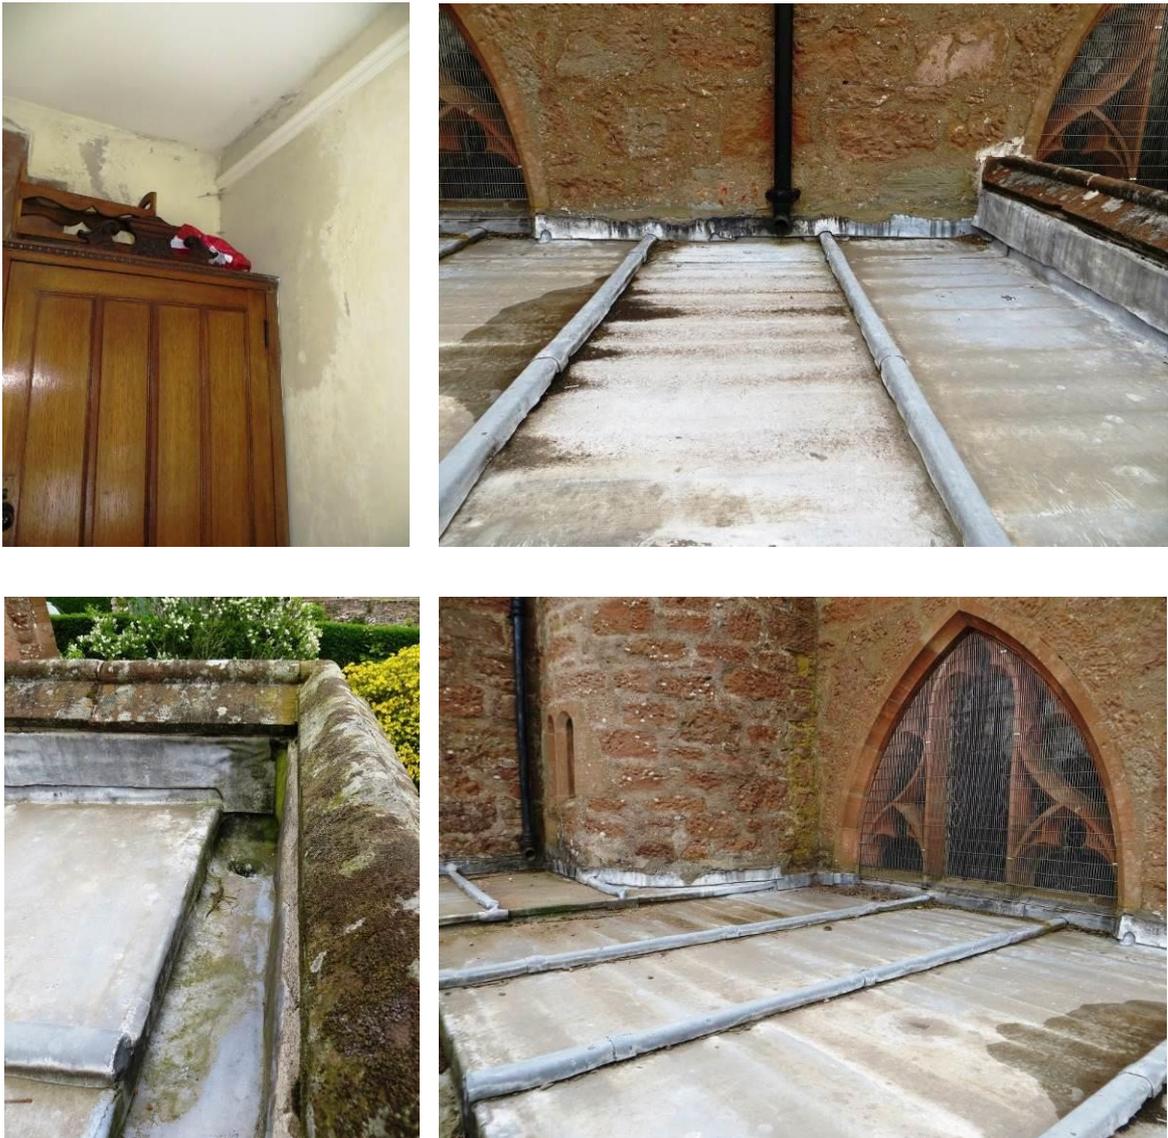
1. The south wall at high level internally with black mould evident (SE wall recently cleaned of black mould; fig 12).
2. The ceiling over the Vestry lobby is cracked from water leakage.
3. In the small toilet, particularly at the south-west corner at high level.

Probable cause: the lead roof is of some age with a number of poor quality flashings and patching of mortar joints between the lead and masonry at upstands (fig 12).

Figure 12: The Vestry has signs of water penetration and mould growth in a number of areas thought to be caused by multiple failures in the ageing lead roof.

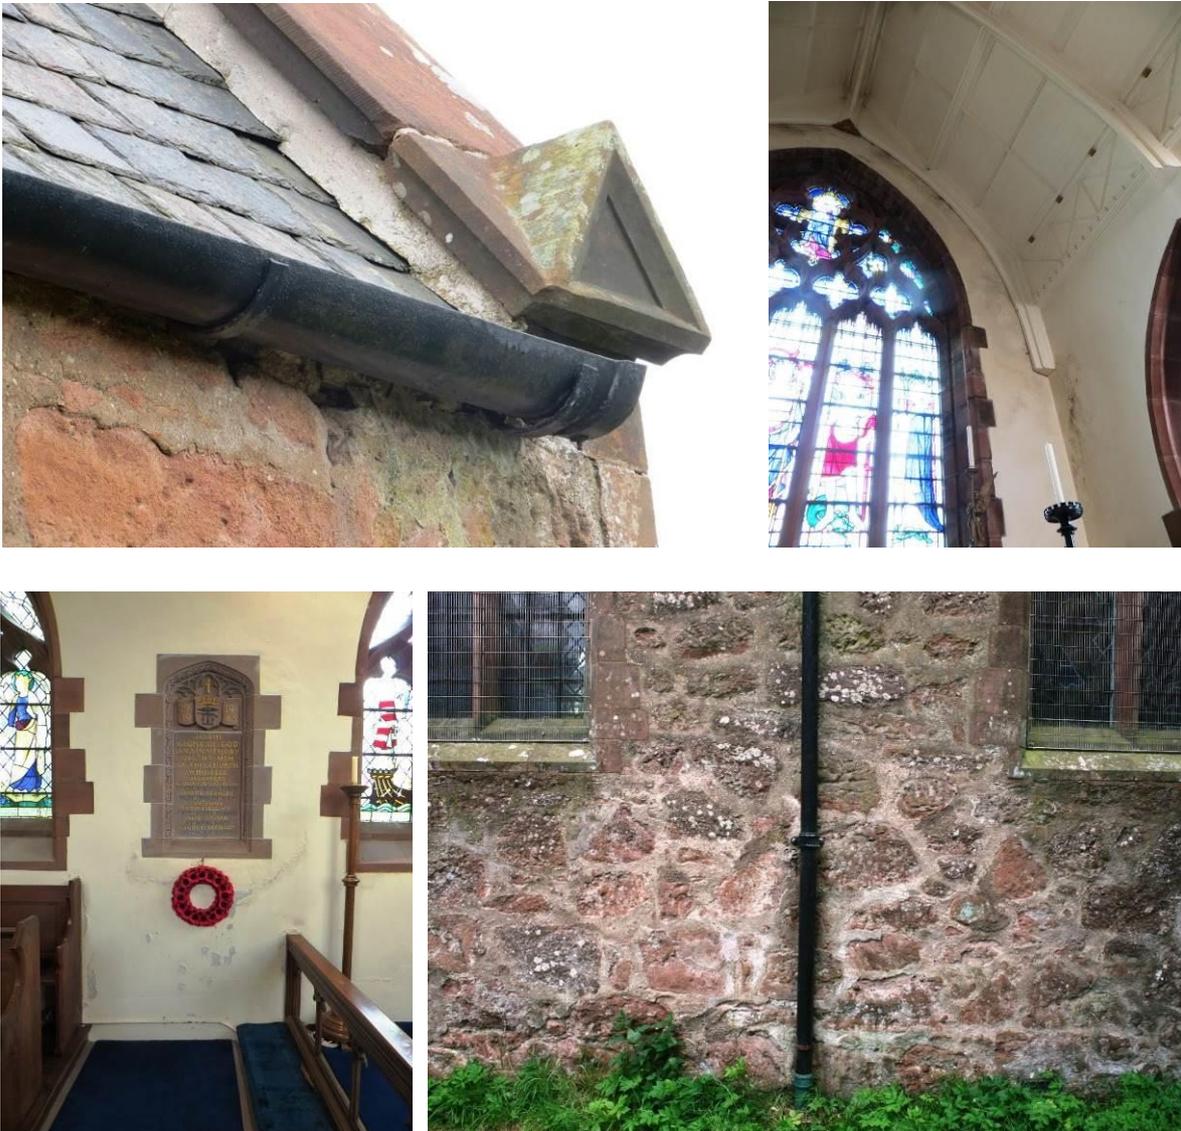
1. The east gable wall at high level on both sides and extending downward (lower area recently cleaned of black mould; fig 13).
Probable cause: the failure of the mortar skew fillet below the copes and damaged/open cope joints. Eroded stonework below gutter at the south-east corner (past defect) could be contributing.
2. Below the war memorial on the north elevation (fig 13).
Probable cause: staining and erosion of masonry externally indicates a previously leaking rainwater downpipe (fig 13). Masonry may be more pervious despite the pipe no longer showing signs of leaking.

Figure 13: The roof junction is only protected by a mortar skew fillet which has lifted off the slate; the east gable of the Chancel shows signs of water ingress at high level and extending down the wall; (below) signs of water penetration and flaking paint finishes below the war memorial, may be historic from defective rainwater downpipe; externally masonry shows signs of erosion around this pipe.

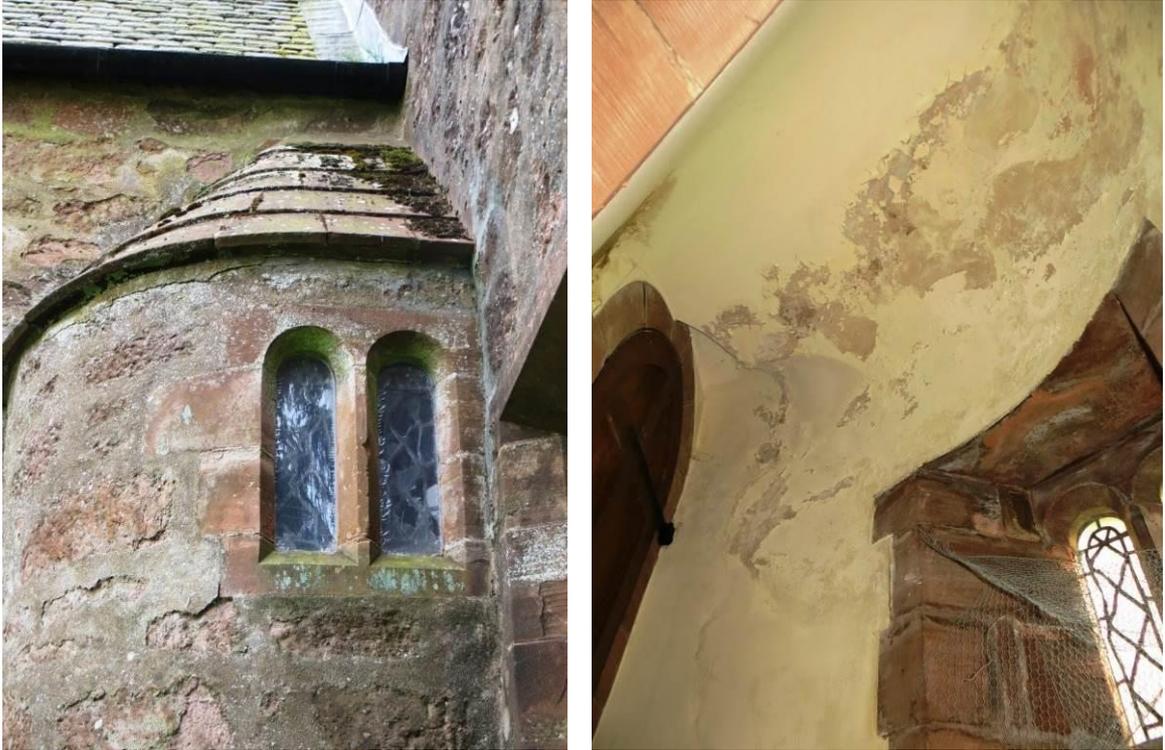
Water ingress is causing damage internally to plaster and paintwork especially to the domed plastered ceiling and also extending downward causing salts to leach through dressed stonework at the bipartite window (fig 14). Extensive black mould reported on internal walls (recently cleaned off).

Probable cause: water leaching through the stone flag roof and joints, with heavy moss build up. No flashings at junctions to Nave and Chancel, only mortar joint; no gutter.

Figure 14: the NE stair tower with stone capped roof and no flashing at junctions with Chancel and east gable wall of Nave; effects of water penetration internally.

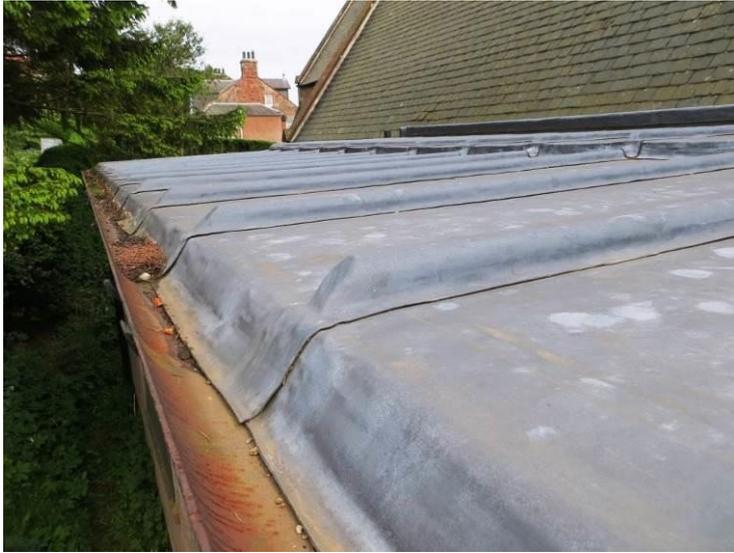
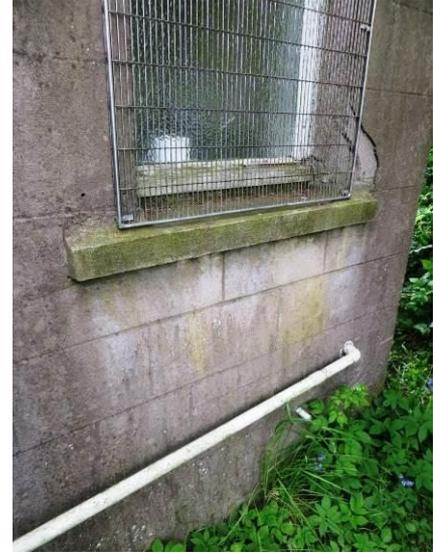
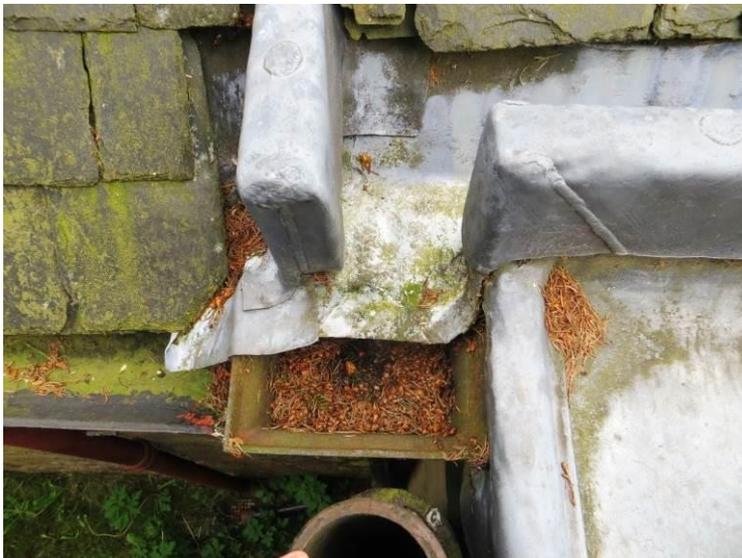
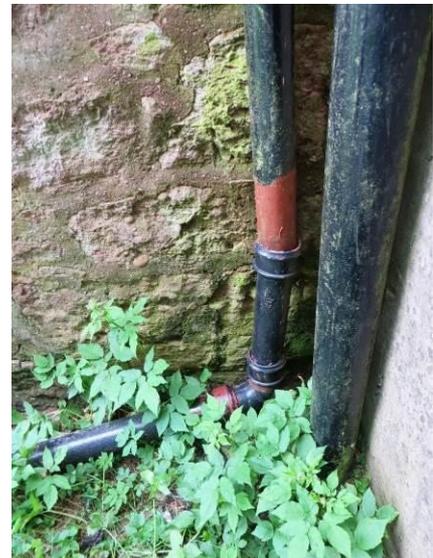
No internal problems evident however render in poor condition with loss of top coat in some small areas and other sections appearing to be boss. The rainwater gutter outlet at the east end of cast iron gutter was choked with pine needles from neighbouring trees. As noted above, at the junction with the Nave, the rainwater hopper was choked and alignment of the downpipe is not true. This is thought to be causing damage in the aisle and could affect the Hall. The north gutter shows signs of rusting and is in need of painting. The timber windows of the Hall extension are in poor condition externally.

Figure 15: cast iron gutter in need of painting and is liable to choking from pine needles from neighbouring trees. Render and timber windows in poor repair; (below) hopper at junction of Hall and Nave also liable to choking and the downpipe is out of alignment.

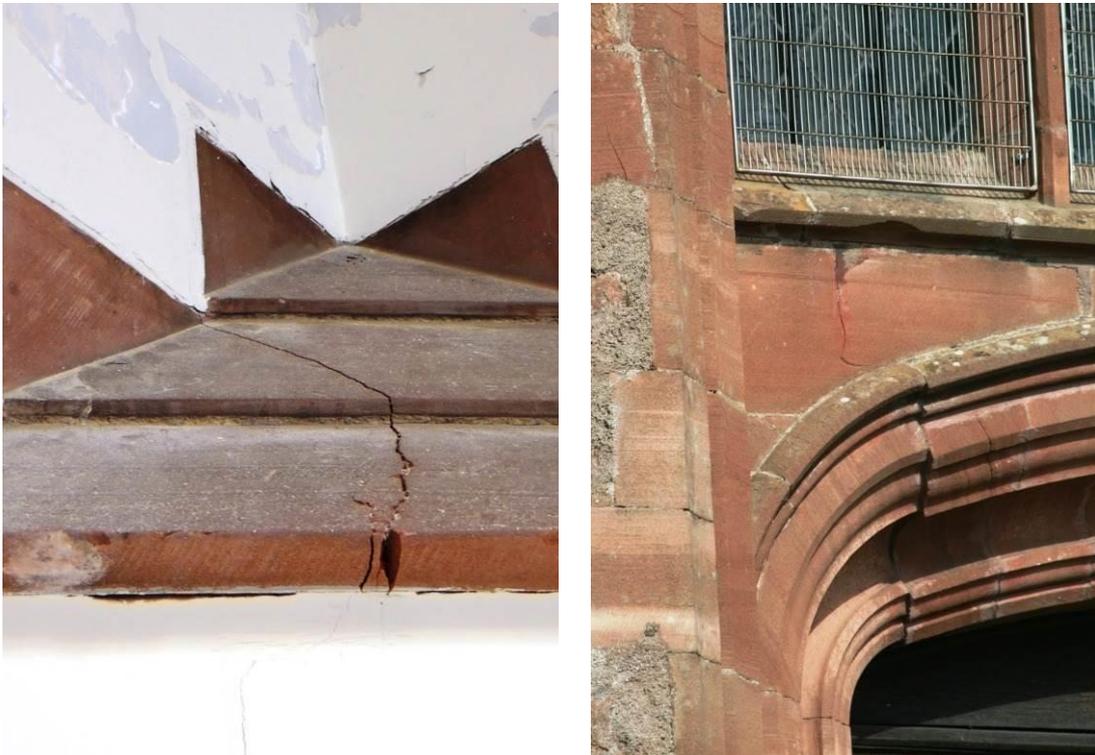
Figure 15: Movement cracks through stonework in the West Tower: over internal access door to stair (left) and above west entrance.

Finally, the observed cracking in the West Tower is reported to be historic, with former repairs evident (fig 15). As not all cracking can be determined to be 'historic' and as a number of cracks have reopened, it is recommended that a structural engineer inspect the building and report in particular on the West Tower. The issue of water in the basement of the West Tower should be further investigated at this time.
